David W. Taylor Naval Ship Research and Development Center

DTNSRDC-86/45 August 1986

DOK-BLOK HULL COATING SYSTEM GENERAL SHIPYARD
APPLICATION INSTRUCTIONS

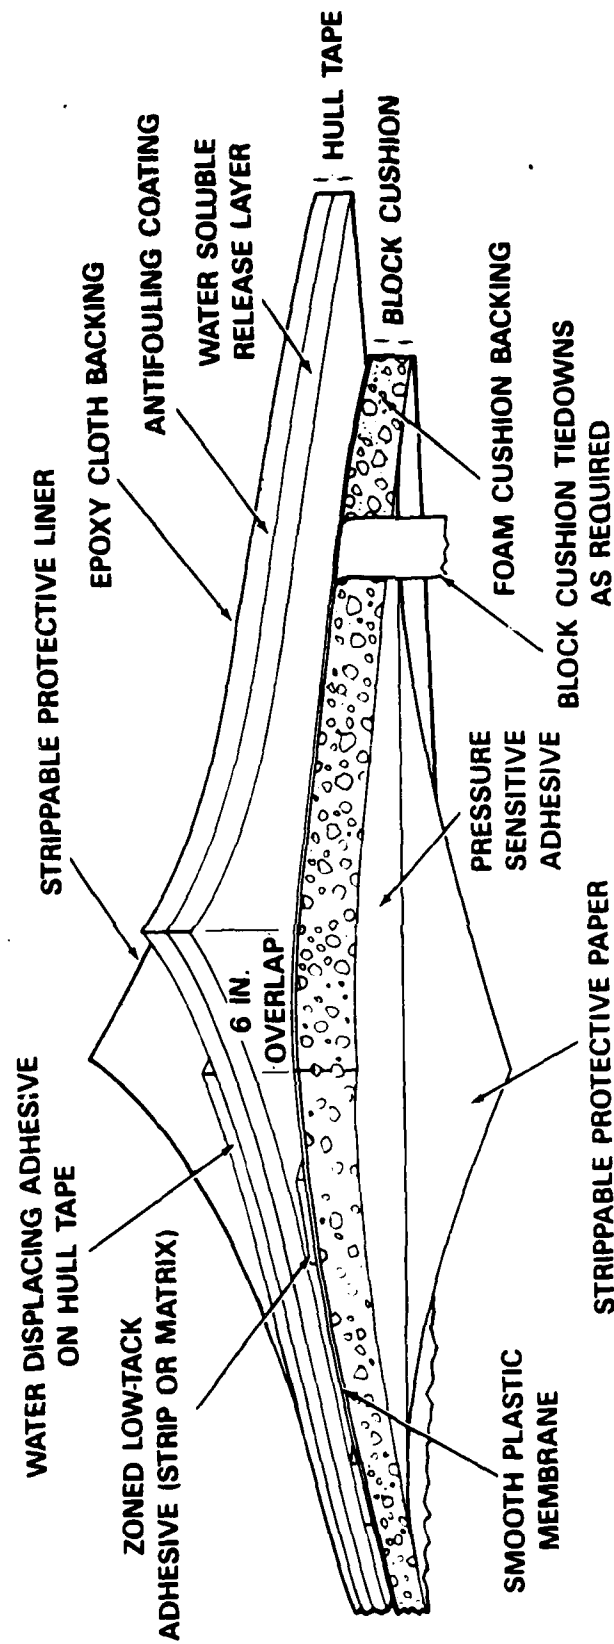
NOTE: THICKNESSES EXAGGERATED FOR DETAIL

Fig. 1. Tape sandwich structure
(thickness exaggerated
for detail)

The DOK-BLOK Hull Coating System consists of two multilayered tape components, combined to form an integral, flexible sandwich structure. See Fig. 1.

5.5 The smaller, thicker block cushion component is deployed face down (white protective paper in place). This face is labelled "Block Side-Down." See Fig. 1.

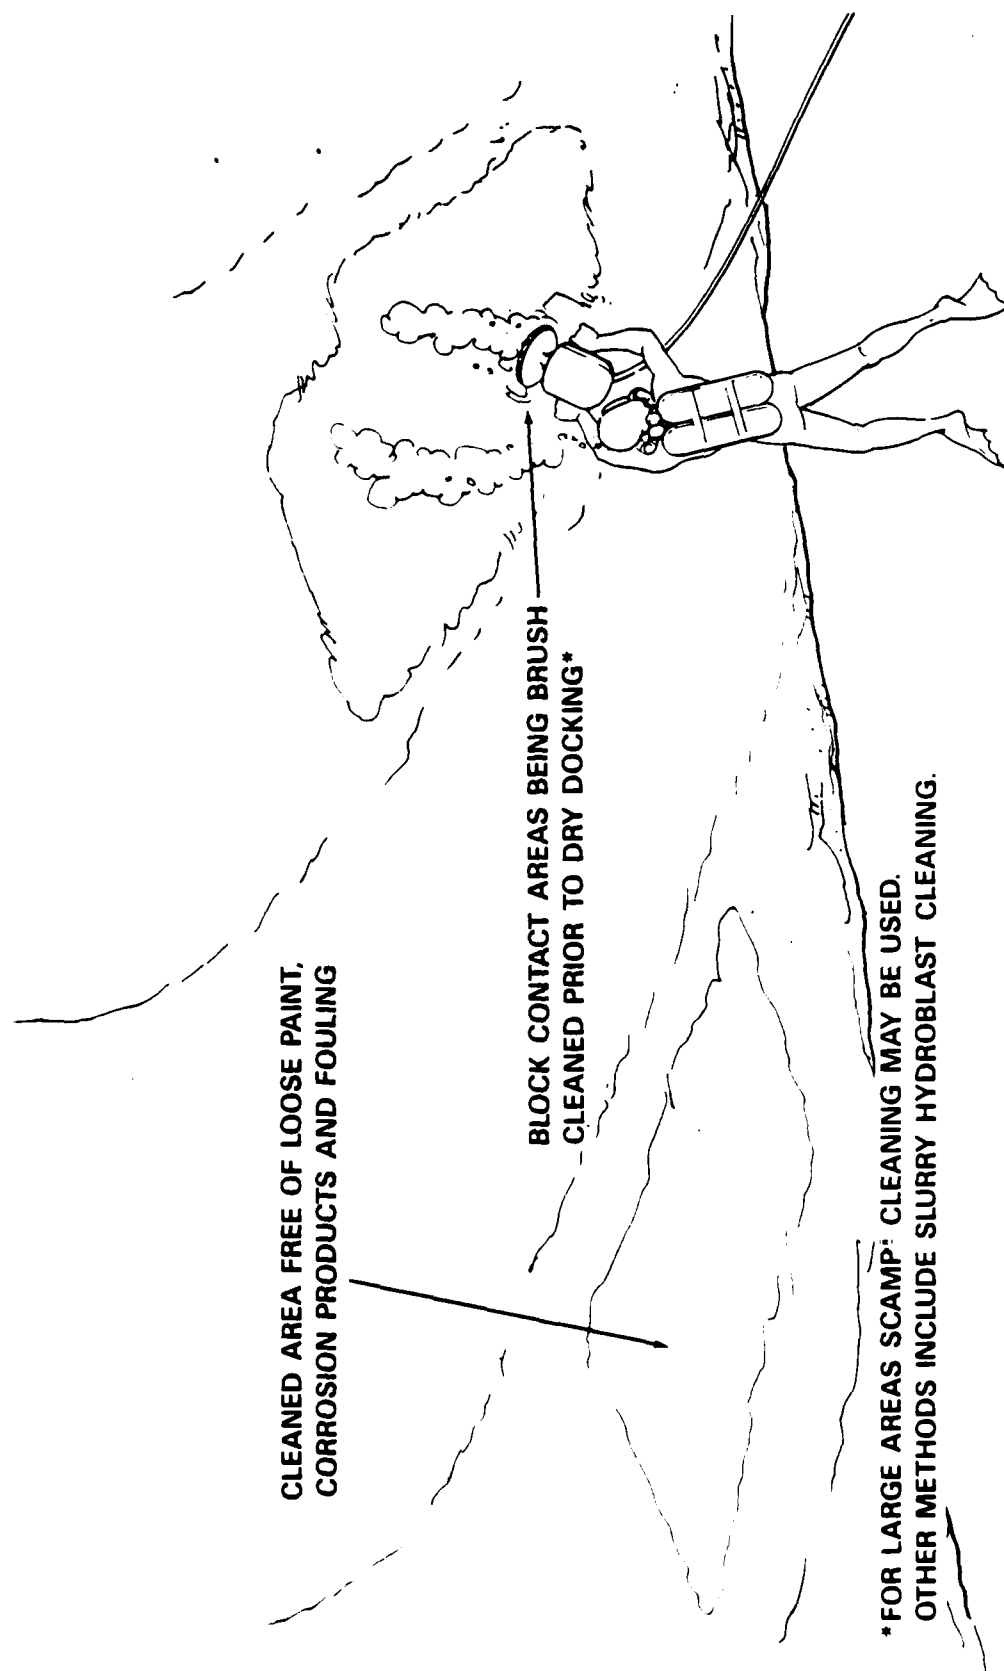
Fig. 2. Diver cleaning operations.

Pneumatically operated scrubbers and stiff, flat rotating wire brushes, as well as high pressure cavitating water jets have been found effective in removing all loose debris and for properly preparing the hull surface to receive the DOK-BLOK system. Hydroblasting with sand slurry is particularly effective. The purpose of this operation is to provide a stable substrate surface for the DOK-BLOK system by removing accumulated slimes, fouling growths, loose paint or corrosion products. Hogging lines may be tied around the ship to guide the diver while underwater. For large underwater areas a Scamp® machine may be used. See Fig. 2.

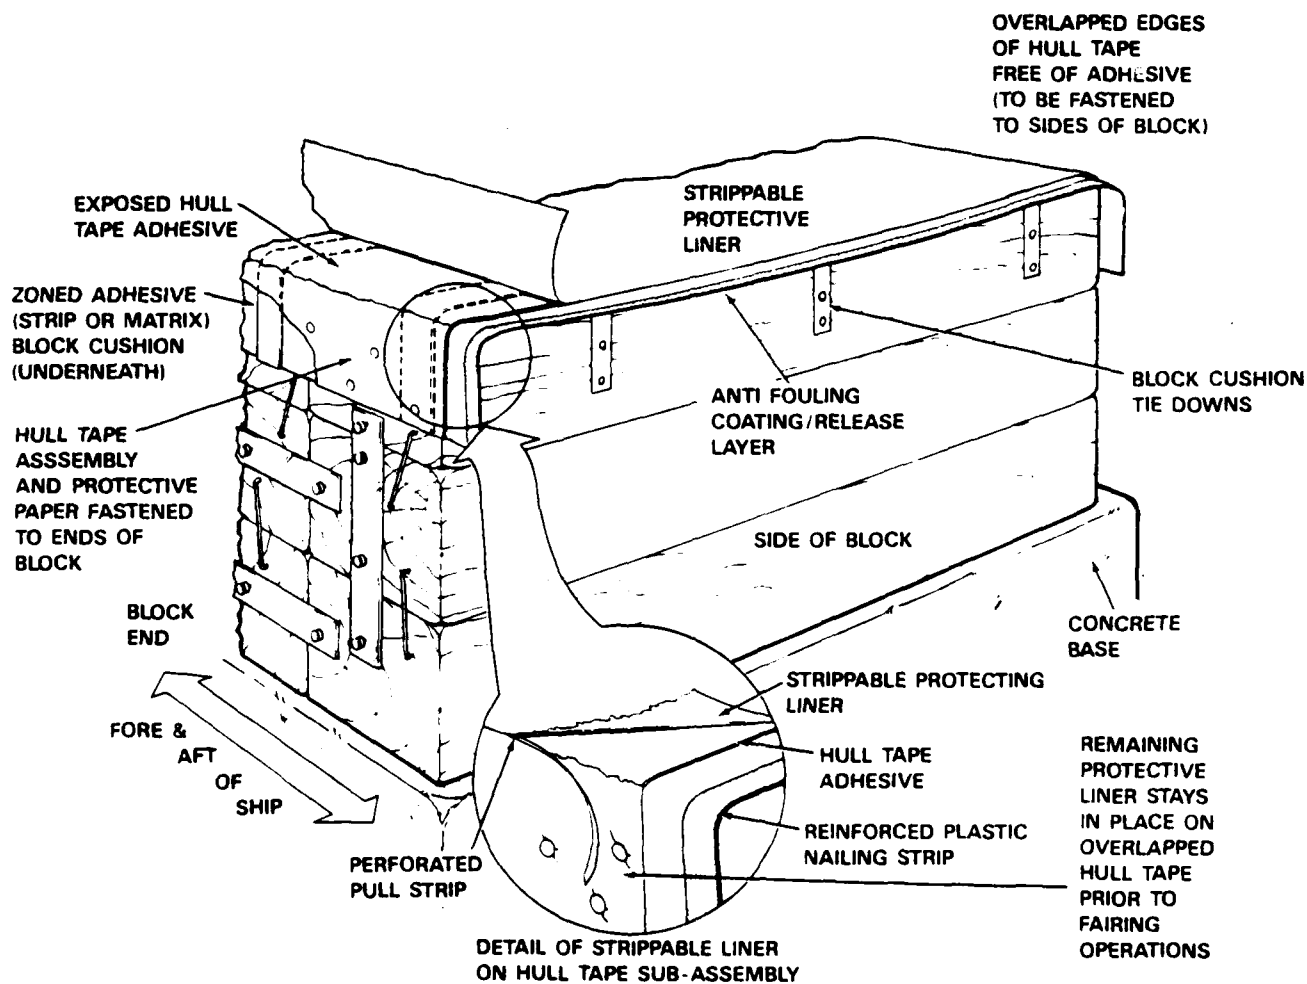
Fig. 3. DOK-BLOK prepositioned on block.

5.6 Remove the protective paper on cushion tape which is usually 42-in. wide. Align edge of cushion tape with side edge of block parallel to long dimension. Center cushion so that a 12-in. overhang (approximately) occurs at each opposite end edge. The hull tape attached to cushion tape will be larger than the width of the block to allow an overhang of 6 in. from each side edge. See Fig. 1. Slowly press cushion tape on block starting at one side and work across the block face. See Fig. 3.

5.7 Where block cushion tie downs are furnished, two men stationed at opposite sides of the block pull the ties tightly down and secure them with roofing nails. Start with the center ties so that the cushion tape conforms to the curvature of the block. Finish tensioning the ties at each end to complete the job. See Fig. 3.

5.11 The overlap tape edges on the secured ends of the block are now folded around the sides and nailed along the reinforced edge (nailer strip). Next the overlap tape edges are pulled tightly down over the sides of the block making hospital corners and nailed securely with roofing nails along the reinforced nailer edge. See Figs. 3 and 4.

5.15 In removing the protective plastic liner, the rip strip on the transverse perforated ends are pulled to separate the liner. See Fig. 3. The protective liner ends remain on the overlapped ends of the DOK-BLOK assembly which is already nailed in place. The protective liner on the bearing face of the hull tape adhesive is removed exposing the pressure sensitive white adhesive.

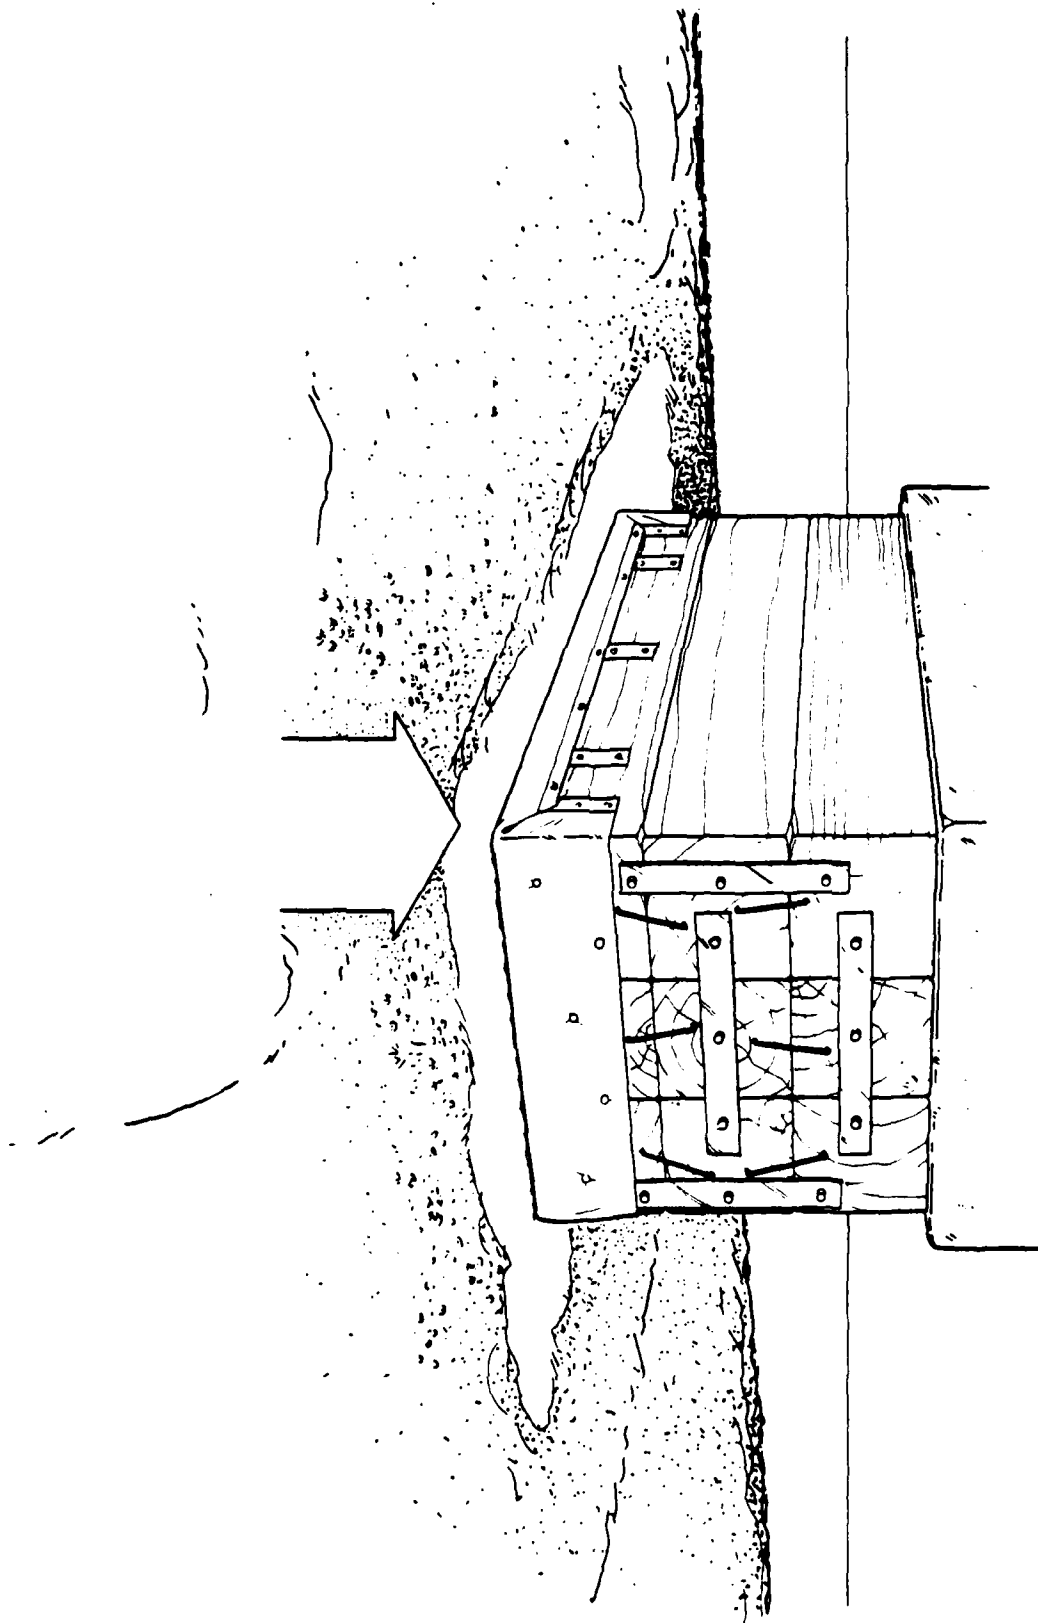
Fig. 4. Ship settles on exposed adhesive of hull tape affixed to block.

5.16 Proceed with drydocking and try to avoid bouncing the ship, unless absolutely required. See Fig. 4.

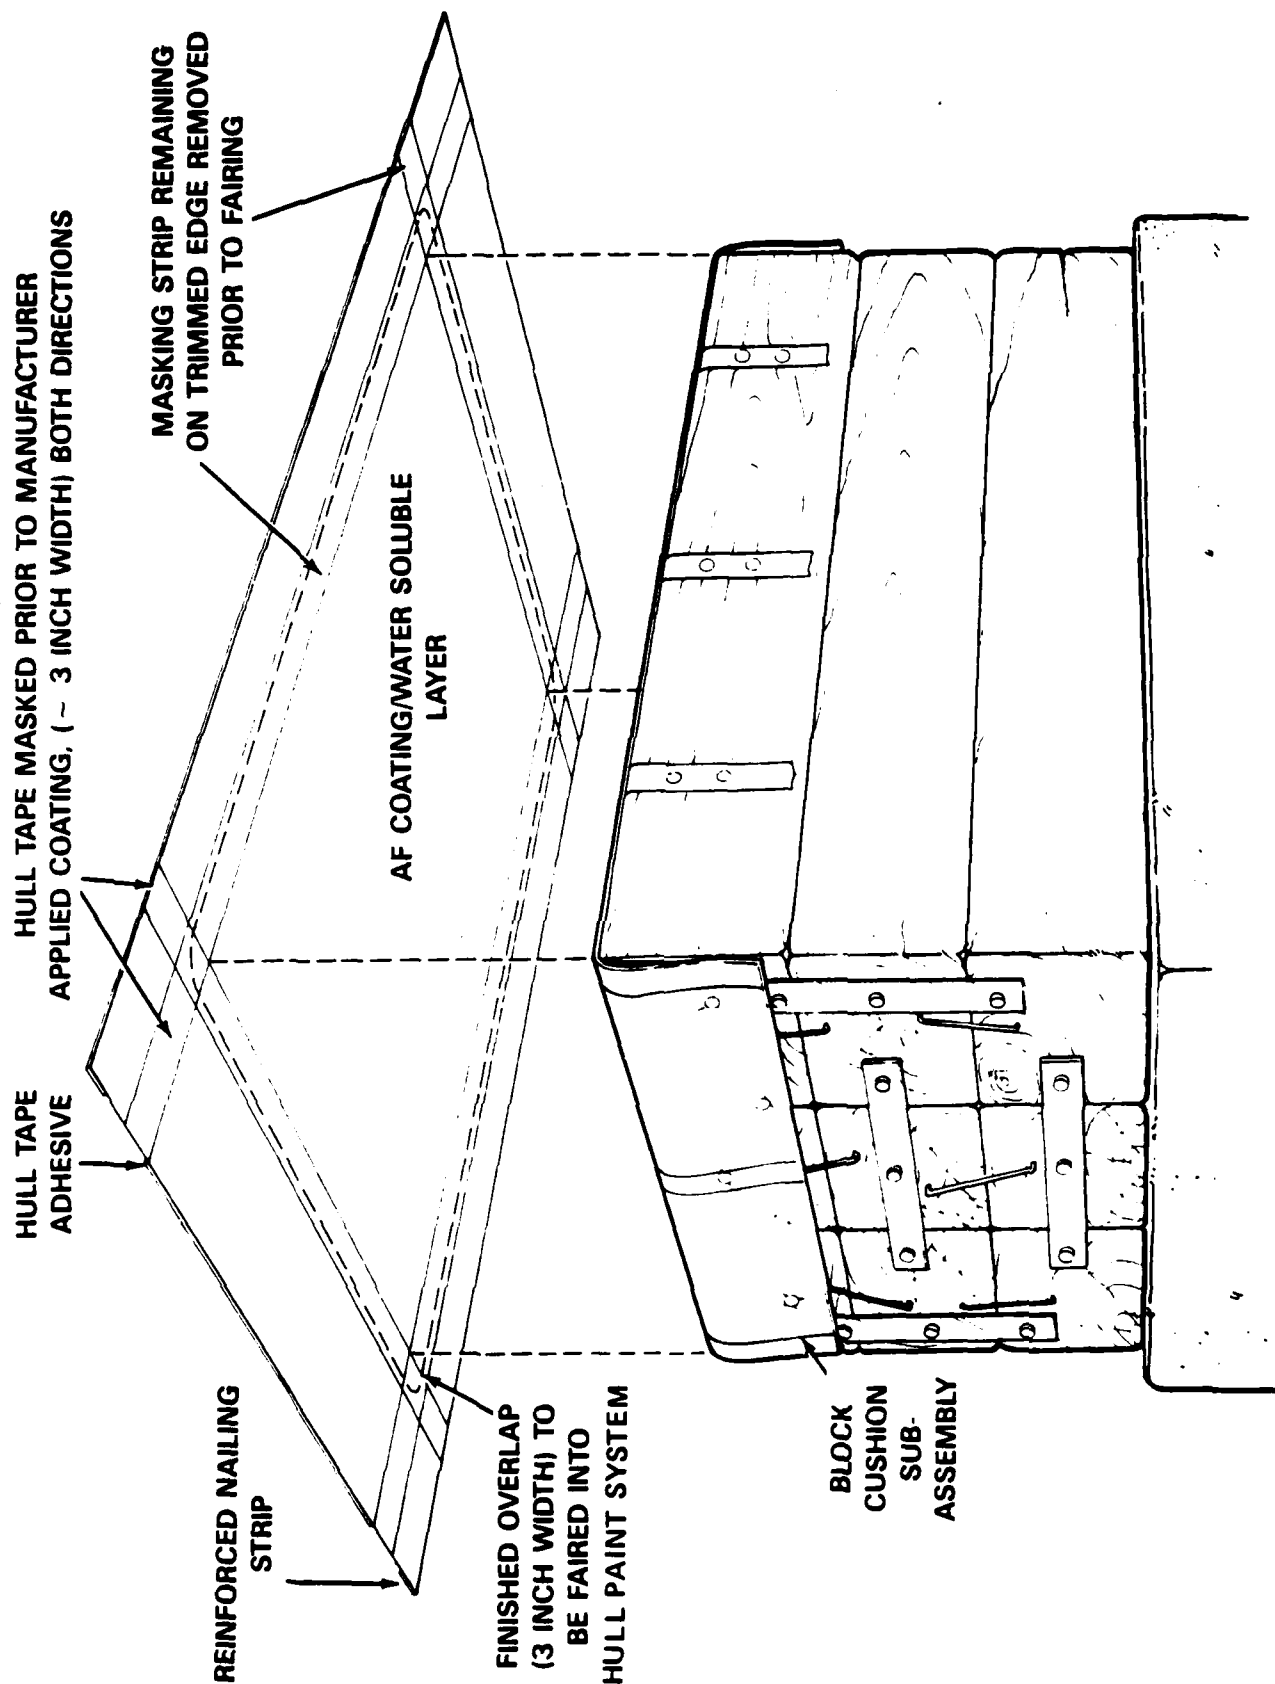
Fig. 5. Hull tape sub-assembly showing detail of masking and trimming.

The hull tape subassembly, where feasible will be manufactured with suitable masking on its painted surface to allow for trimming and proper edge treatment. See Fig. 5. Completion of the application and edge treatment procedure will require the following steps to be performed on each docking block in the sequence listed:

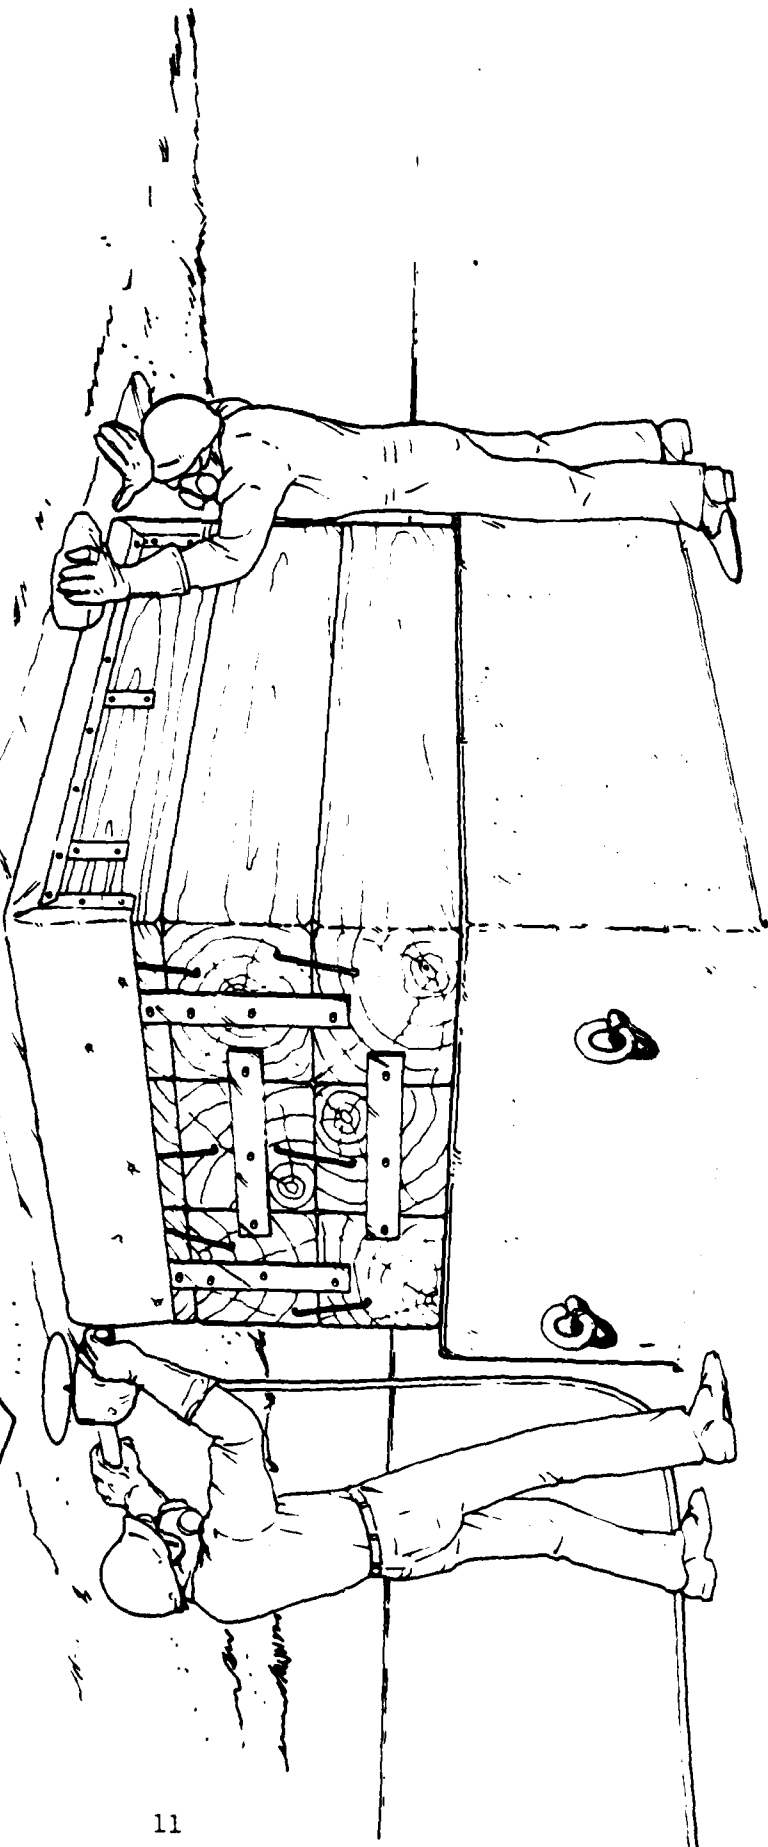
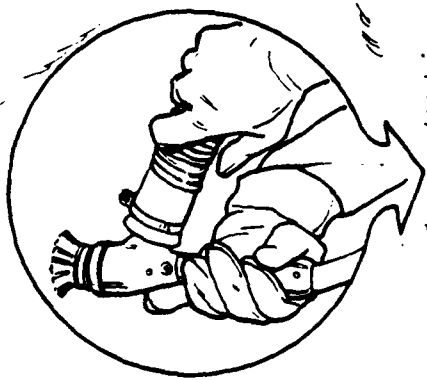
ALTERNATE
VACUUM
BLASTING,
LESS LABOR
INTENSIVE

Fig. 6. Hull carefully cleaned and solvent wiped for
4 to 6-in. around perimeter of block.

6.1 Clean hull in a 4 to 6-in. band around block perimeter with a power abrader or a vacuum abrasive blaster. See Fig. 6.

6.2 Wipe abraded area with solvent soaked clean rags (toulene) or paint thinner. See Fig. 6.

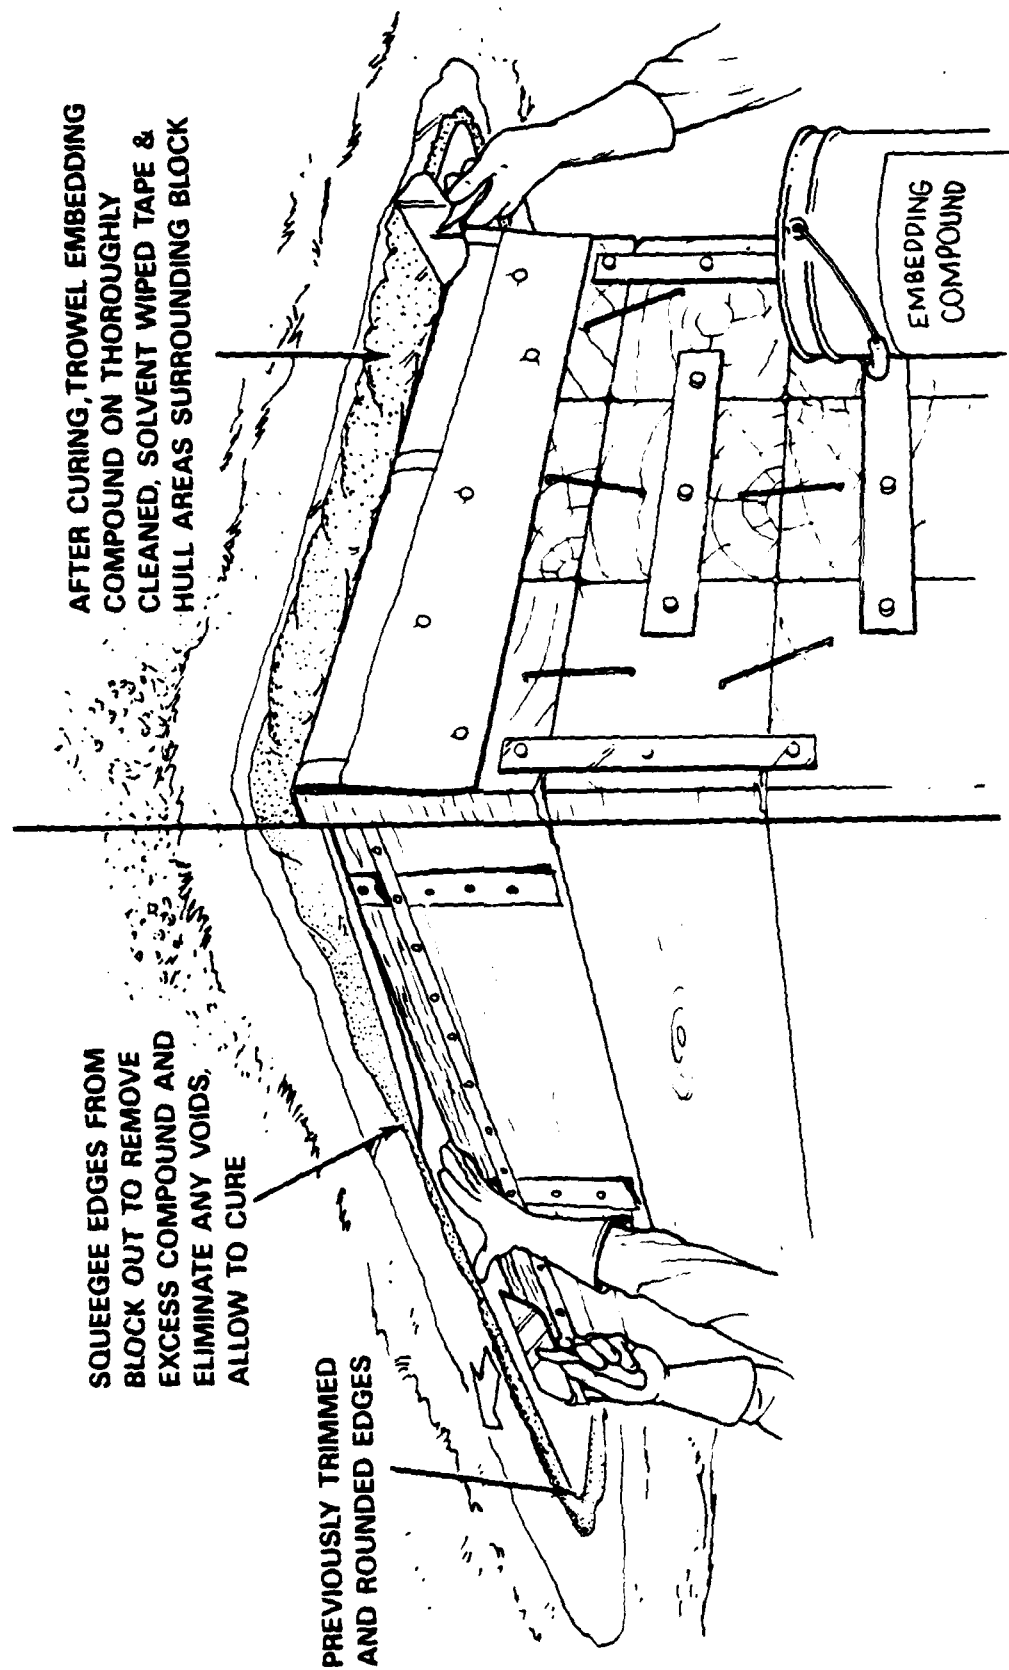
Fig. 7. Embedding of hull tape edges.

6.3 Trowel black fairing compound (properly mixed) on hull at prepared surfaces (3 to 4-in. band) all around block perimeter. See Fig. 7.

6.6 With flat flexible trowel, squeeze excess fairing compound under tape. Working trowel from block edges outward to tape edges. Leave little or no excess compound on hull. See Fig. 7.

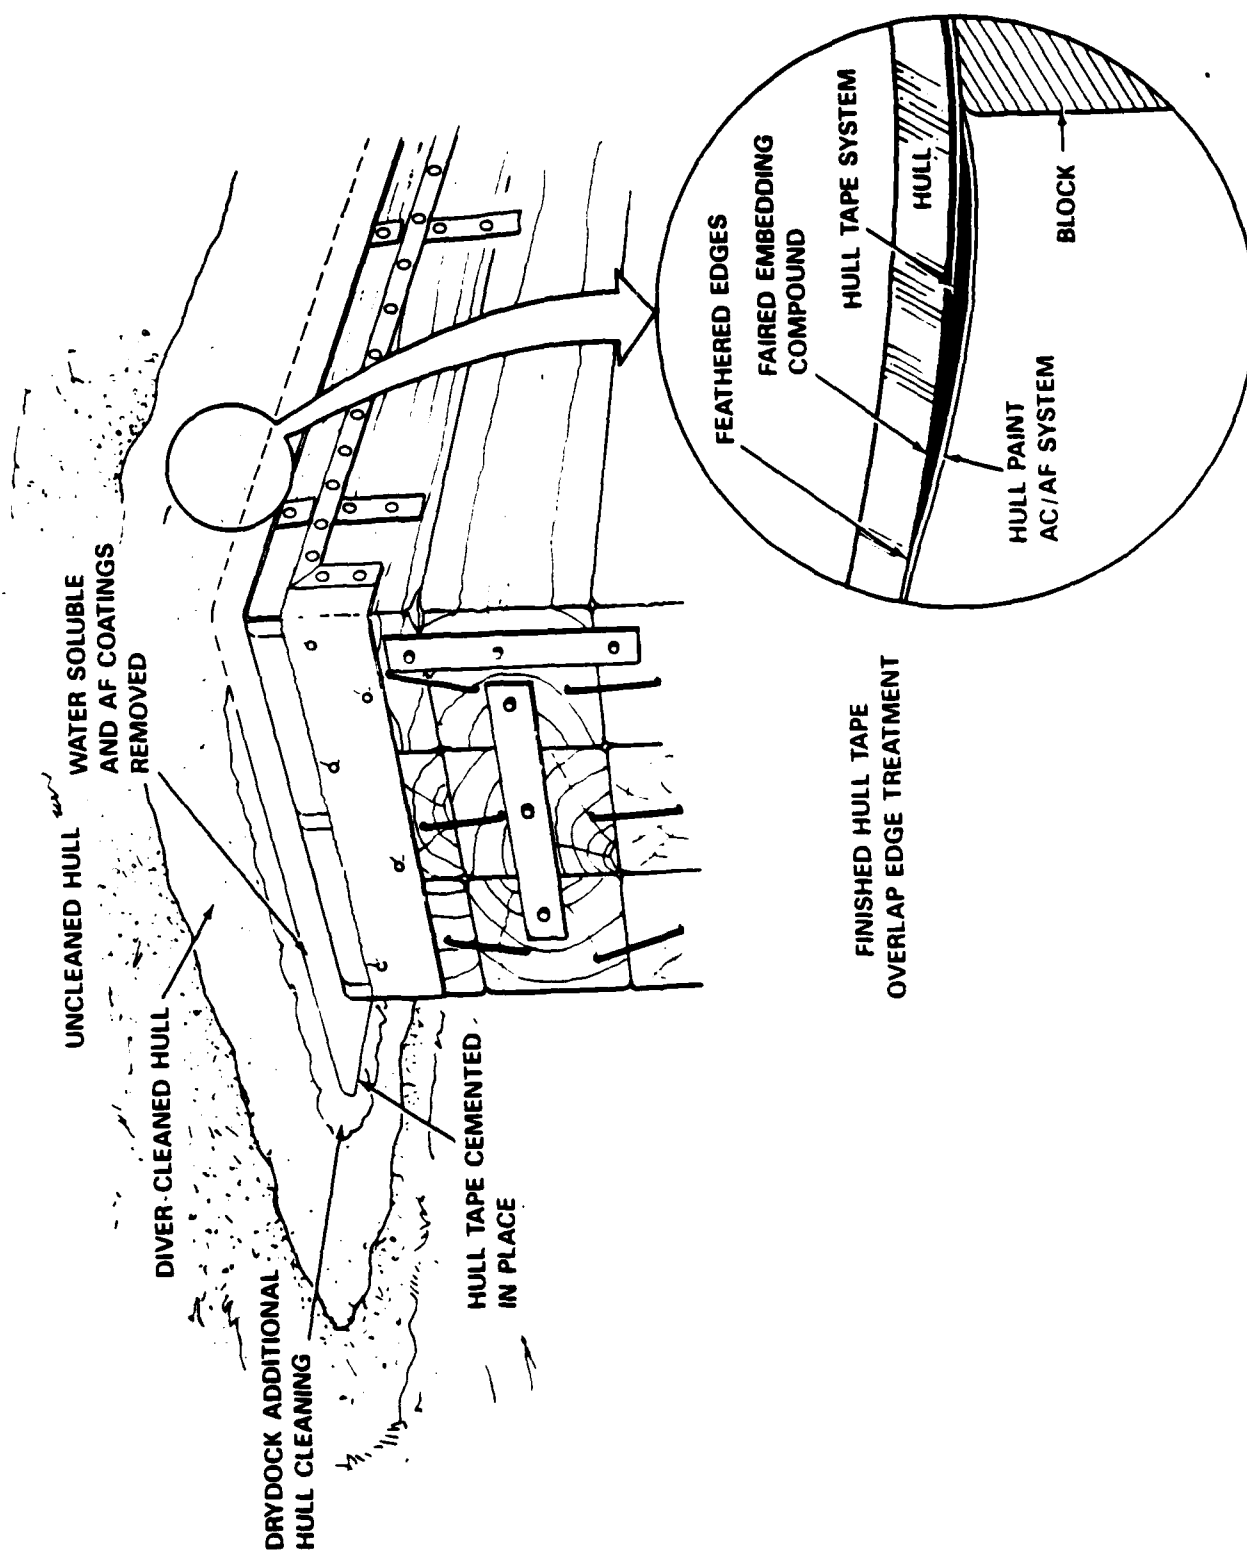
Fig. 8. Finished hull tape overlap edge treatment.

6.9 With trowel, smooth compound and draw down to thin layer. Feather compound to hull so that tape edges are no longer visible. Allow to cure. See Fig. 8.

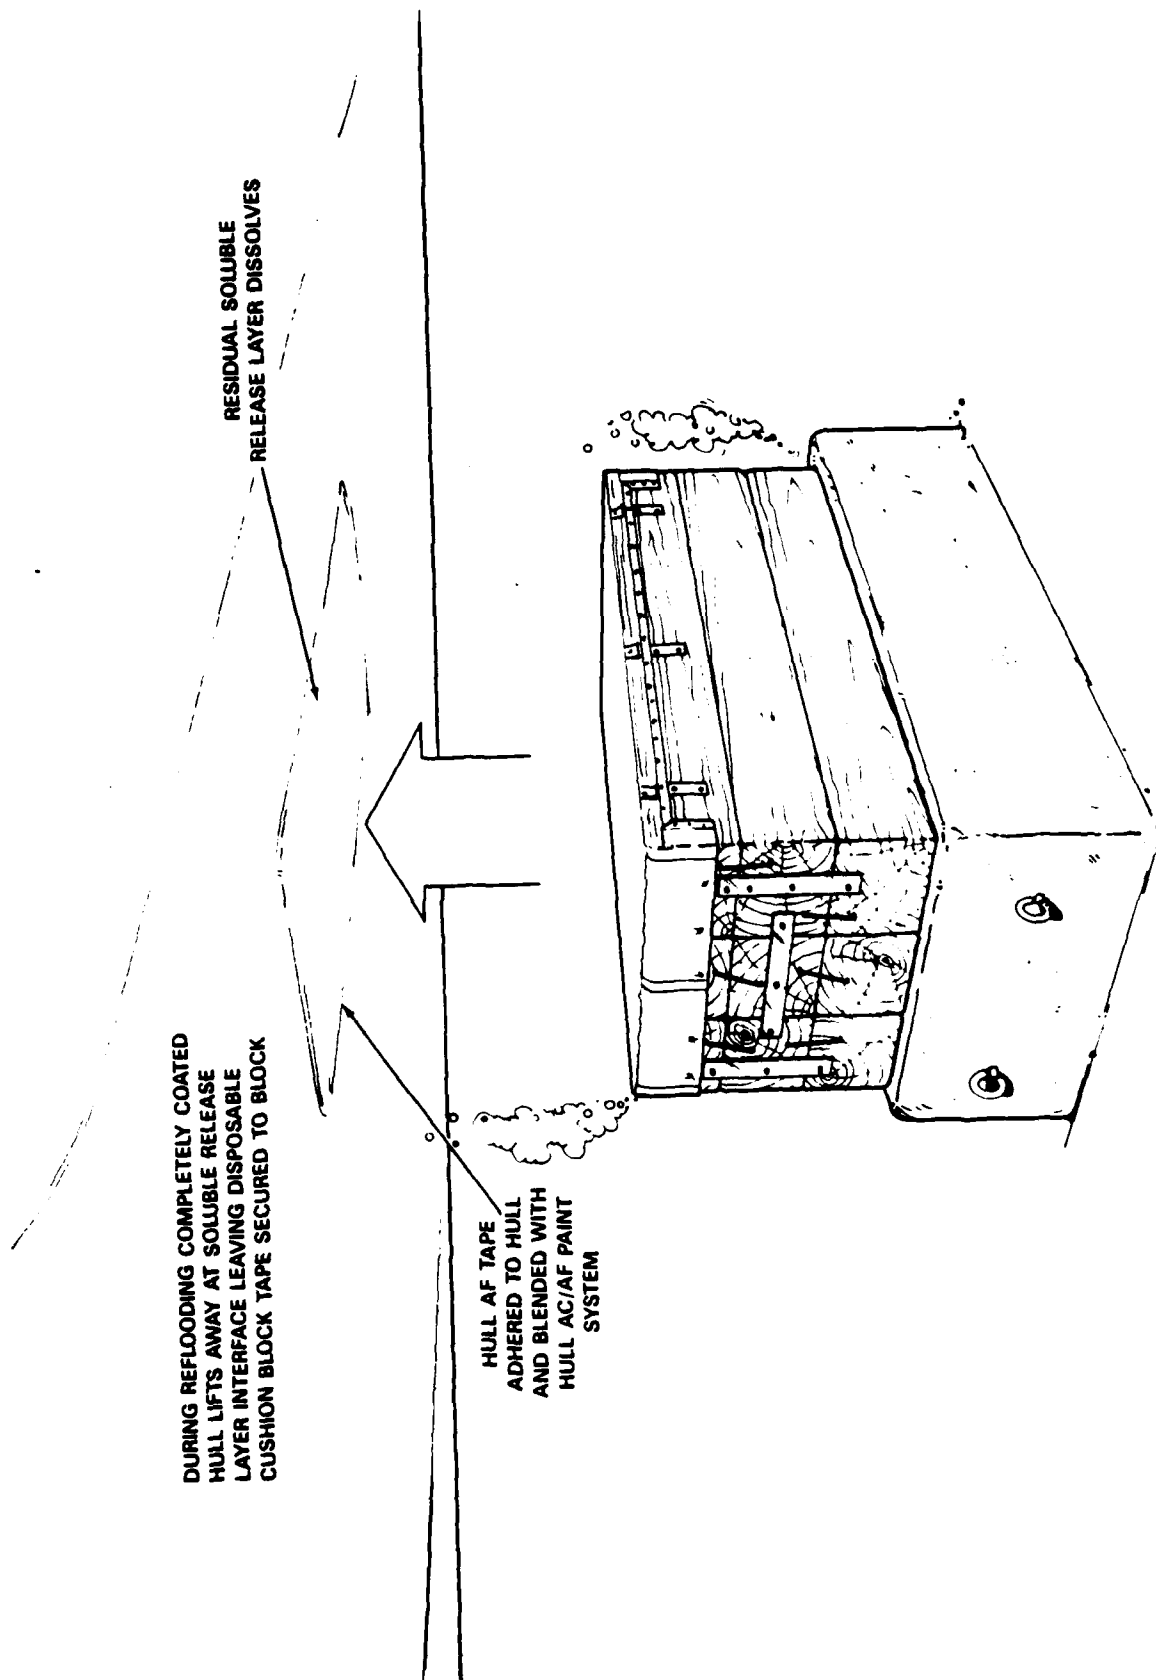
Fig. 9. Undocking
